## Small Missile Impact & Cyclic Wind Pressure Test.

(FBC TAS 201 & 203)

**HETI-09-2531**

Fixed Window (EFCO 3900) retrofitted with 8 mil CONCORD  
Security Film.

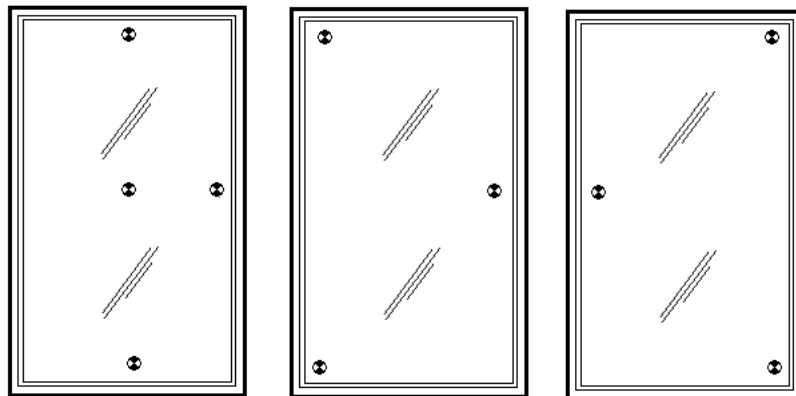
Sample # 1

Sample # 2

Sample # 3

⊕ Impact Locations

Impact Location	Speed (fps)	Observations (in)	Description of Result
<b>Sample # 1 (Reference Report HETI-09-2531)</b>			
(1) Center	130	-----	No Penetration or Failure
(2) Right Edge of Glass	130	-----	No Penetration or Failure
(3) Bottom Edge @ Center	130	-----	No Penetration or Failure
(4) Top Edge @ Center	130	-----	No Penetration or Failure
<b>Sample # 2 (Reference Report HETI-09-2576)</b>			
(1) Right Edge of Glass	130	-----	No Penetration or Failure
(2) Top Left Corner	130	-----	No Penetration or Failure
(3) Bottom Left Corner	130	-----	No Penetration or Failure
<b>Sample # 3 (Reference Report HETI-09-2577)</b>			
(1) Left Edge of Glass	130	-----	No Penetration or Failure
(2) Top Right Corner	130	-----	No Penetration or Failure
(3) Bottom Right Corner	130	-----	No Penetration or Failure

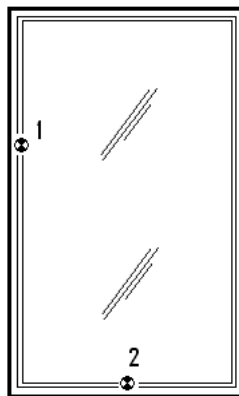
⊕ Gage Locations
